Higgins House Assessment

Prepared for:
Michele Moure-Reeves, Executive Director
Hardy County Convention and Visitors Bureau
202 Winchester Avenue
Moorefield, WV 26836

Prepared by:
Gerald Milnes
107 Earle Street
Elkins, WV

May 22, 2020

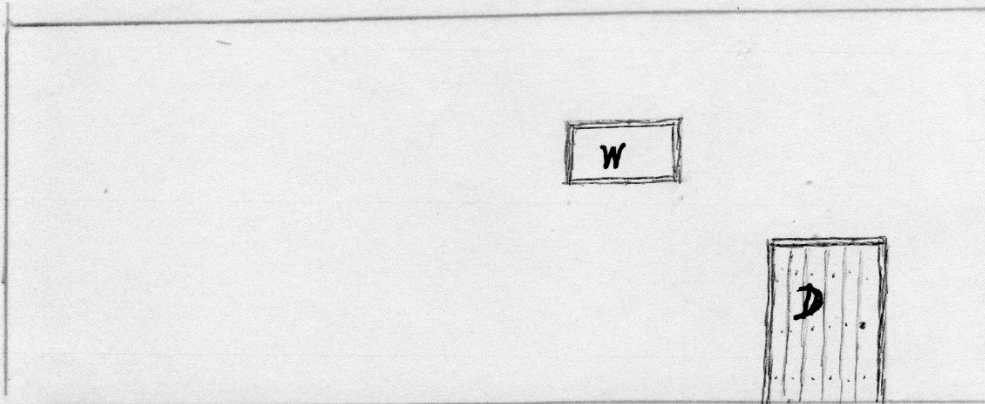
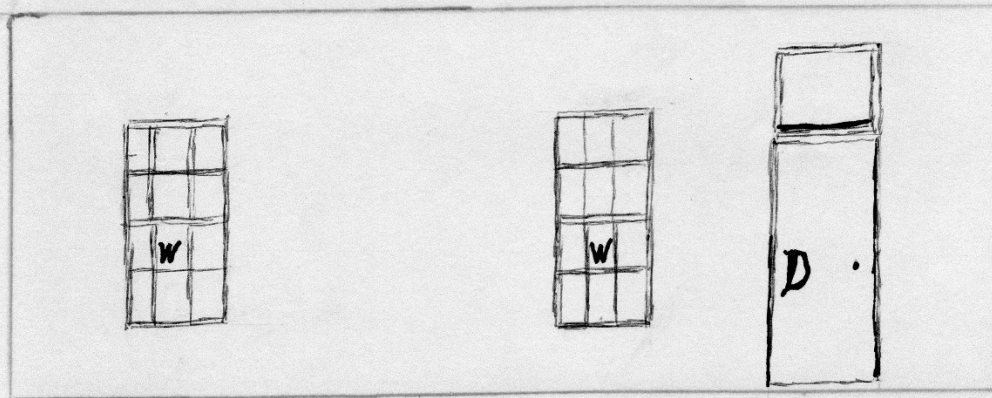
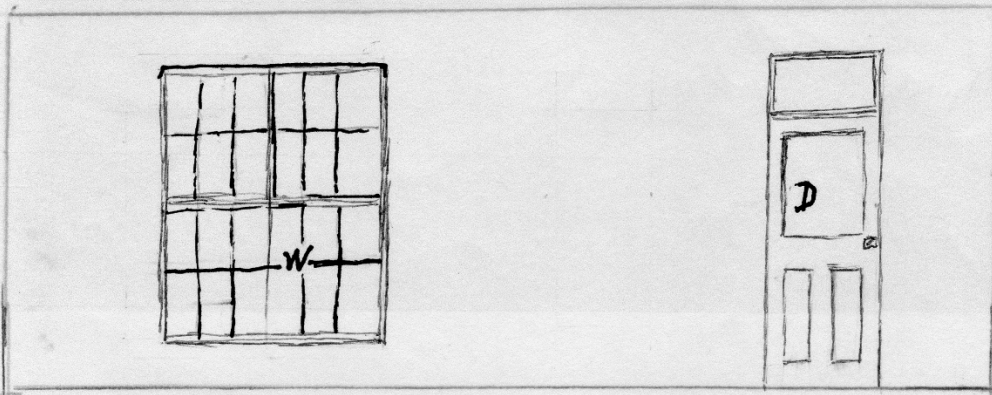
Sketch 1

South Wall, First Floor, Interior View (Sketch 1, below)

Renovations to the south first floor wall show a progression of reconstruction. At the same time, all the first alterations of the north and south walls on both floors were similarly accomplished as well. There are more minor renovations on the east and west sides. The horizontal opening in the top log of the 1st floor front (south) wall was originally the top of the original window opening. The log below it, also has a similar opening on its lower side (See Figure 13) If this second (lower) log was flipped 180 degrees, both openings would correspond and align with each other, making it the original window opening, most likely, the only window of the original house first floor plan. This could be proven by nail holes if modern chinking and clapboards did not hide the evidence. During later reconstruction, this log was flipped over to minimize the opening that had to be chinked and filled. Instead of the larger original window opening, two smaller areas were filled with billets and mud (now modernly re-chinked). (See Figure 14)

There were two successive alterations to the original first-floor front of this house (See Figure 15, and Sketch 1). The first deviation from the original plan created two windows. One was bordered on the right by the vertical board and the other is marked by the brick filler^{xviii} (marking the left side of this former window, see Figure 16). Probably at this c. 1840 juncture, both the front and back doors were heightened to conform with more up-to-date practice. The front door may have had its transom added at this point, or during the later alteration. At this c. 1840 point, the occupants wanted more light in the room, but also, they wanted to alter and formalize the fenestration as societal values modernized and shifted, and popular forms had begun to usher in new ideals and sensibilities. The older period log homes and ways of life were being scrutinized. These “improvements” may be seen in the south upper and lower walls, as well as the first and second floor walls on the north side, which have alterations like the first-floor south wall.

The second major first floor alteration, circa 1890, added the large casement windows that are in the spaces now present, replacing the two first-floor windows with a dual window. Current windows, facings, and trim probably replaced more traditional 6 over 6 windows at the modern date when the plaster was removed. This took place after the demolition of the large house addition in 1988.^{xix} During the c. 1890 alteration, logs were shifted again for this newer large casement window. In measuring the logs, these two successive alterations are possible. It explains the vertical board seemingly inserted into the walls, as the logs were shifted (to the right) on the three instances on both floors where the vertical boards appear mid-walls.

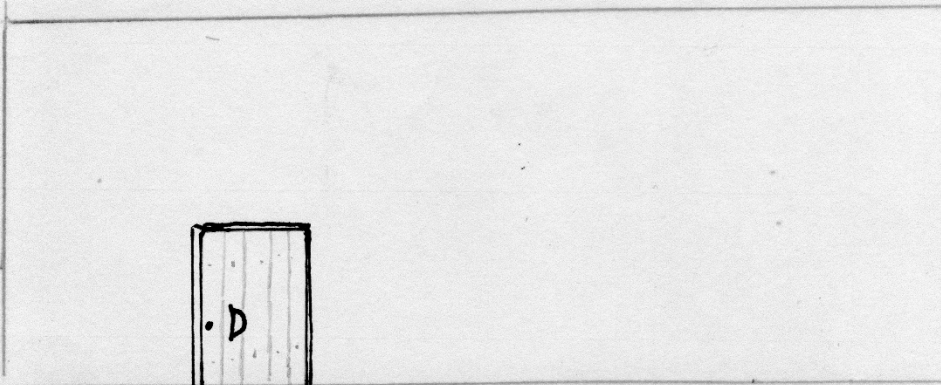
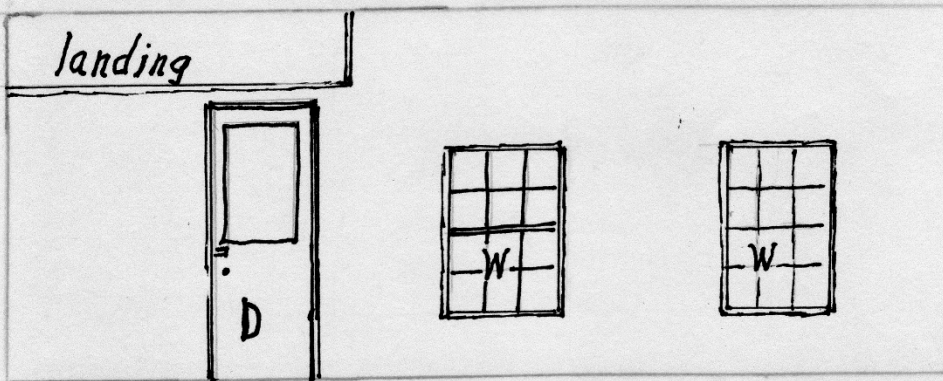
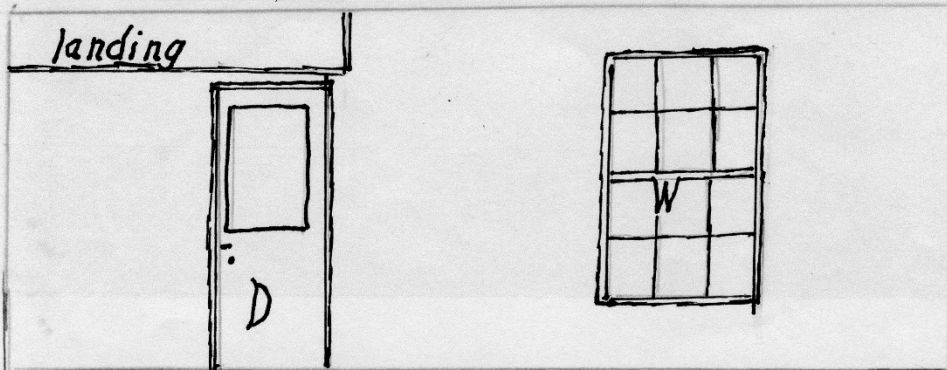
Sketch 2

North Wall, First Floor, Interior View (Sketch 2, below)

Original plan included the low height door on the left, but no windows. The first renovation installed two windows, one delineated by the vertical board marking its left side, seemingly inserted in the wall, and one replaced and filled with brick. The second and final renovation slid the logs to the left, butting up to the vertical board, and shortening them. This allowed the large window, seen at present, to be installed. These alterations mirrored similar alterations on the first floor, south wall. (See Figure 17)

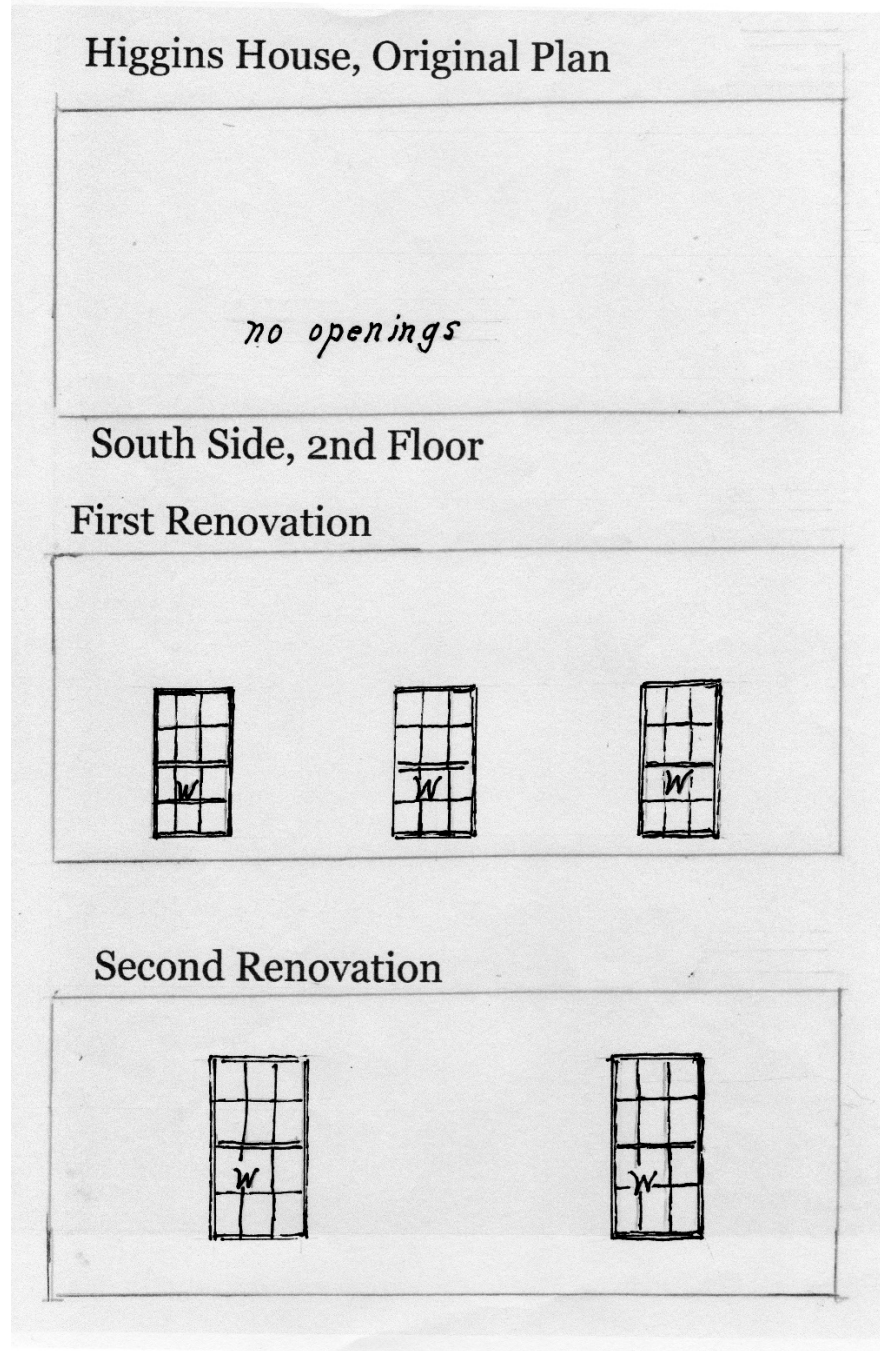
Sketch 3

South Wall, Second Floor, Interior View (Sketch 3, below)

The original plan included no windows. The first alteration placed three equally spaced windows in this south wall, during the c. 1840 renovation. The final renovation, c. 1890, positioned two windows, equally spaced, and was accomplished by sliding logs to the right to butt the vertical board. (See Figure 18)

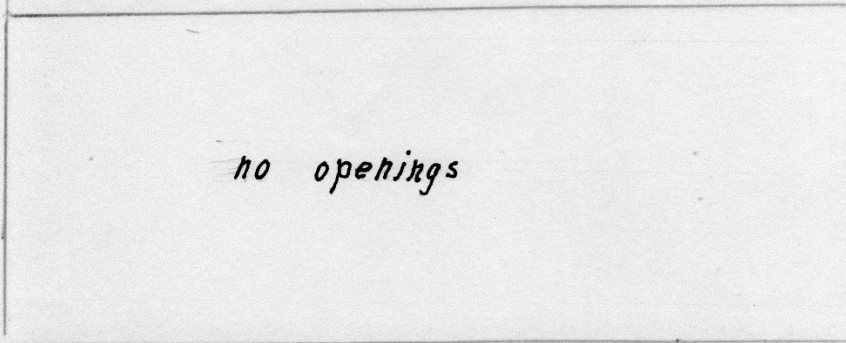
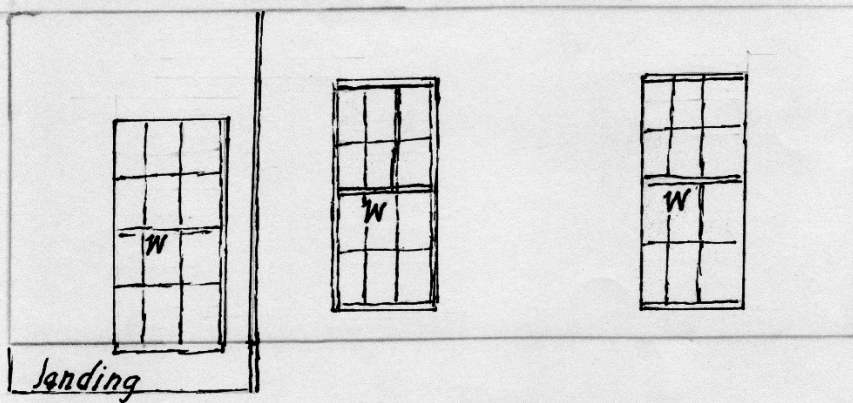
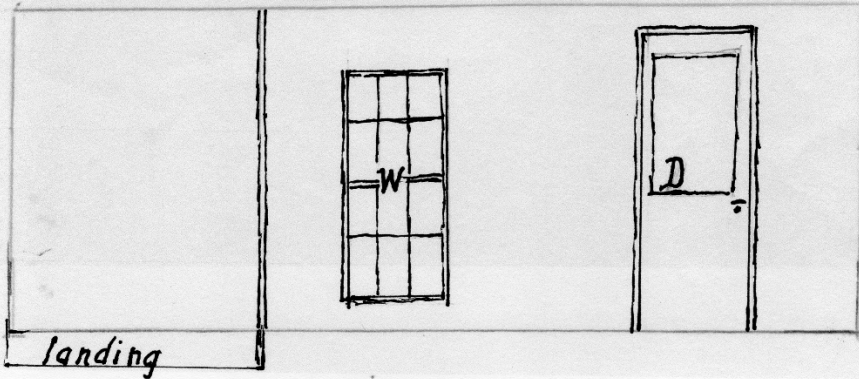
Sketch 4

North Wall, Second Floor, Interior View (Sketch 4, below)

Originally this wall was blank. As with both north and south walls, two successive alterations took place. The first alteration placed two windows (as seen by log notches at top of both door and window, and bottom of window. (see Figure 19), at the time the stairwell was incorporated. A landing-level window was added for light. At the c. 1890 juncture, a window of a slightly less height was installed and a door to the new back-upstairs porch was added, replacing the right-side window. (See Figure 20). The window to enlighten the stairs, installed c. 1840, was filled with brick at this time and plastered over (See figure 21).

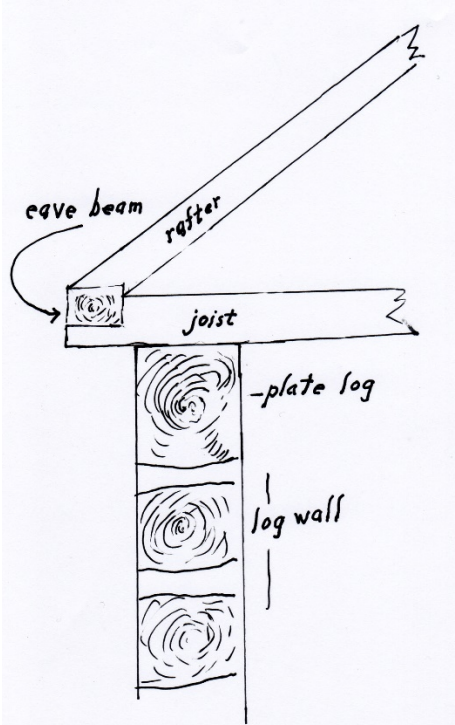
The gable roof rafter structure at present is original. It consists of hand-hewn tapered rafters, notched into the eve beams (See Sketch 5, Below). These are lap-joined and pinned at the apex with a “tree nail” (See Figure 22). They are on 36” centers.^{xxii} The gable end has framed trapping above the tie beam, consistent with this type of rafter system. There is no center roof board which is common in this era. The joists notched into the eve beam (See Sketch, below) and joists rest on the plate log to create an overhang from the wall logs. The one loft window is traditionally placed. However, the current window is a replacement of the original.
